## MEMORANDUM

| <b>SUBJECT:</b> | February Weekly Progress Report @ Gold King |

**Project:** Gold King Interim Water Treatment Plant (IWTP)

**Report No.:** 6

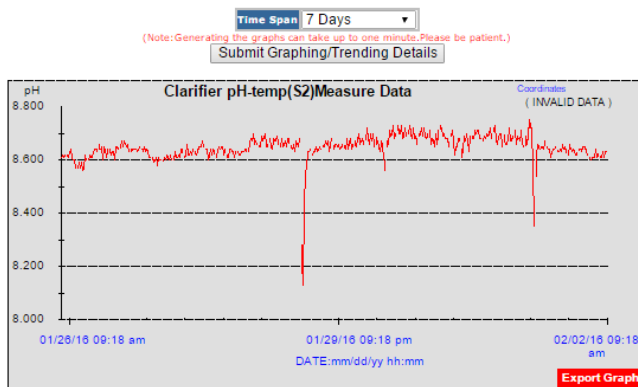
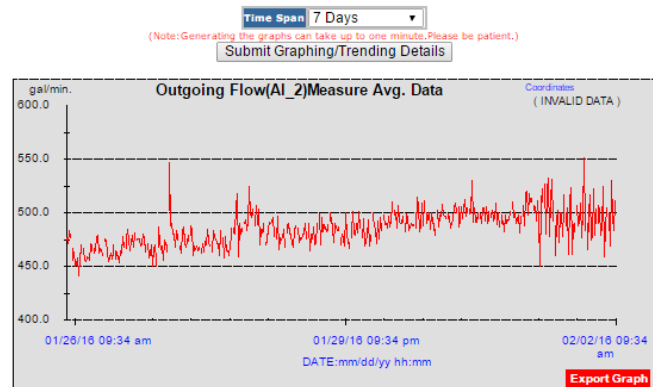
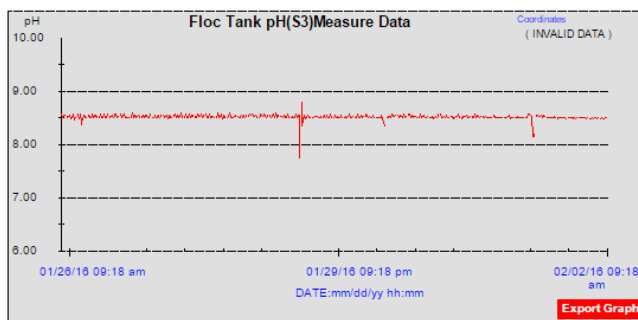
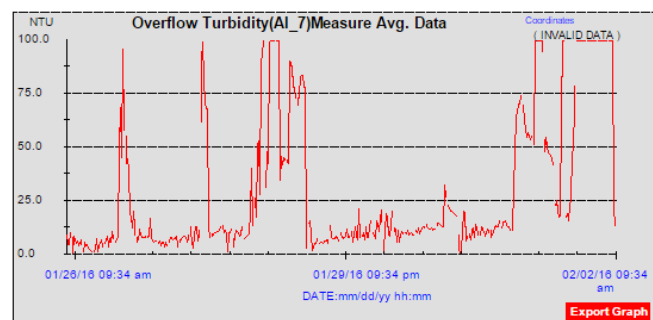
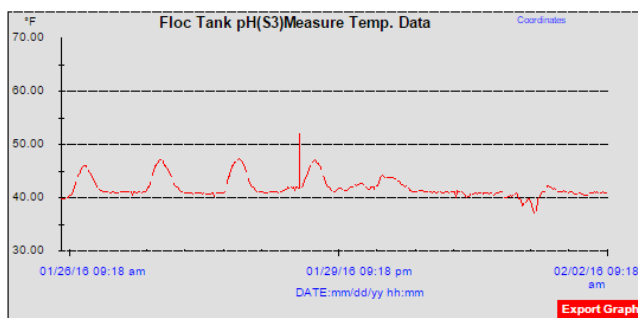
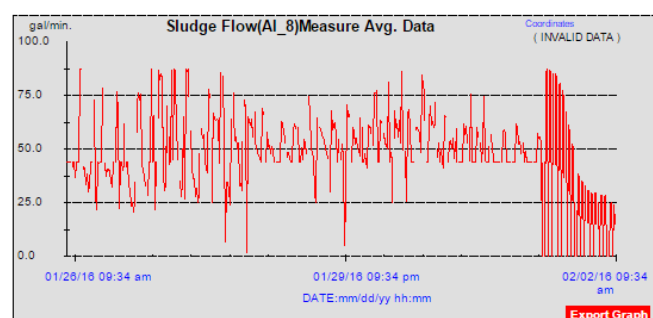
- The following graphs provide trending information collected by datalogging equipment during the previous 7 days. These dataloggers collect control information from the Lime Circuit (left) and Flow Circuit (right) Programmable Logic Controllers (PLCs) at the Gold King IWTP. Over the reporting period (1/25 – 2/1/16 inclusive) Alexco treated 5.06 million gallons at an average of 502 gpm, with 5 gpm released from the sludge storage system and 497 gpm to the discharge line.

- Please note: Each day, the Alexco operators check the pH at both the floc tank and clarifier discharge. During this time, the probe is placed in vinegar (acid), and three pH buffers – 4, 7, and 10. While the probe is in the buffer, the datalogger may capture one of those points for tracking purposes, which explains the frequent periodic (daily) pH spikes seen on the graph.

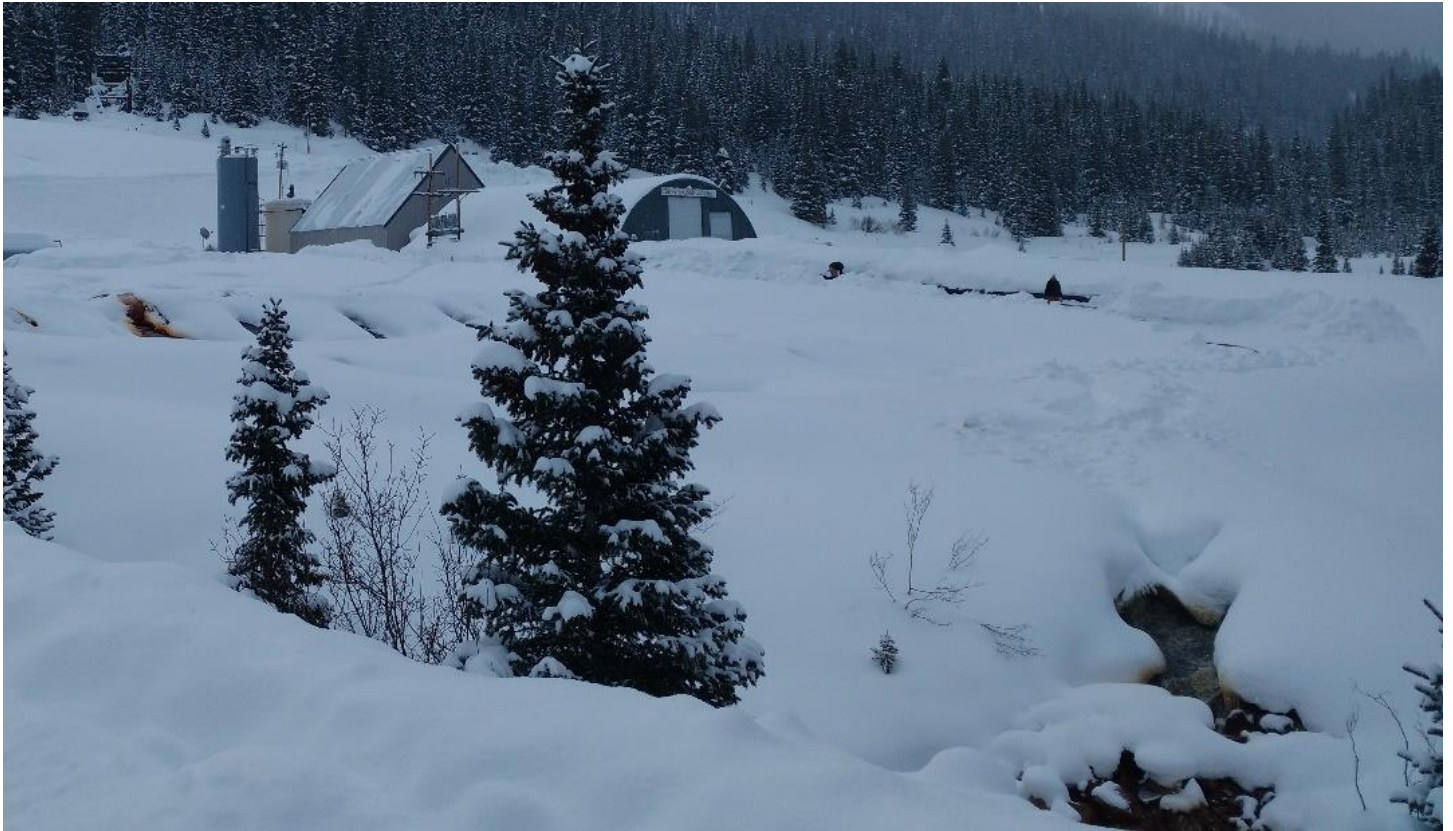
Figure 1: Site from County Rd. 110 – Taken on 1/19/2016

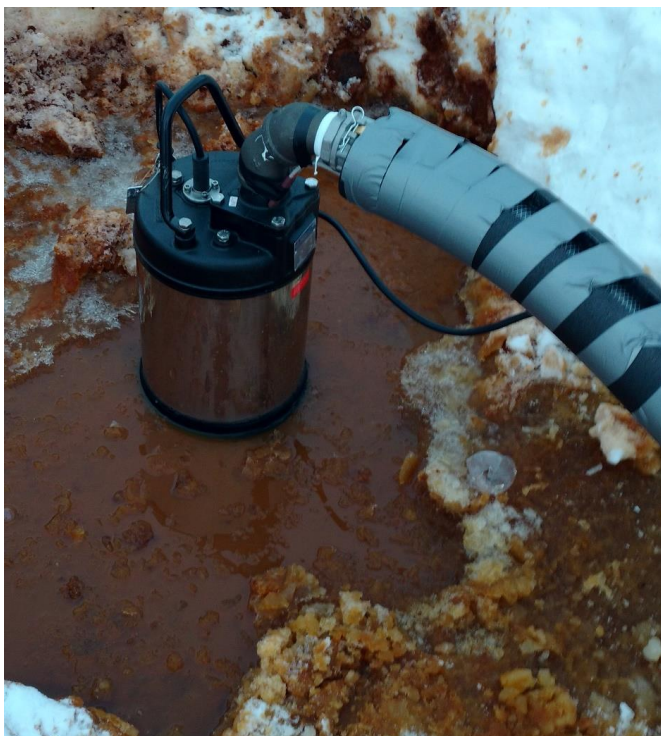
Figure 2: 5 hp dewatering pump installed in Cell D – Taken on 1/19/2016

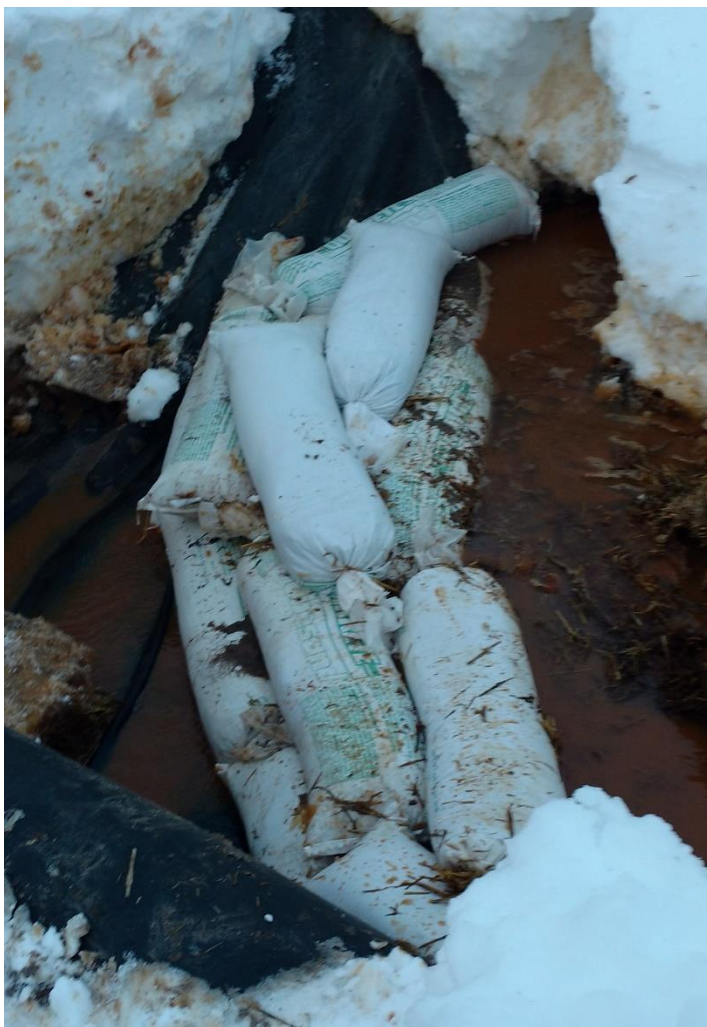
Figure 3: Sand bags installed near the spill-way into Cement Creek – Taken on 1/19/2016

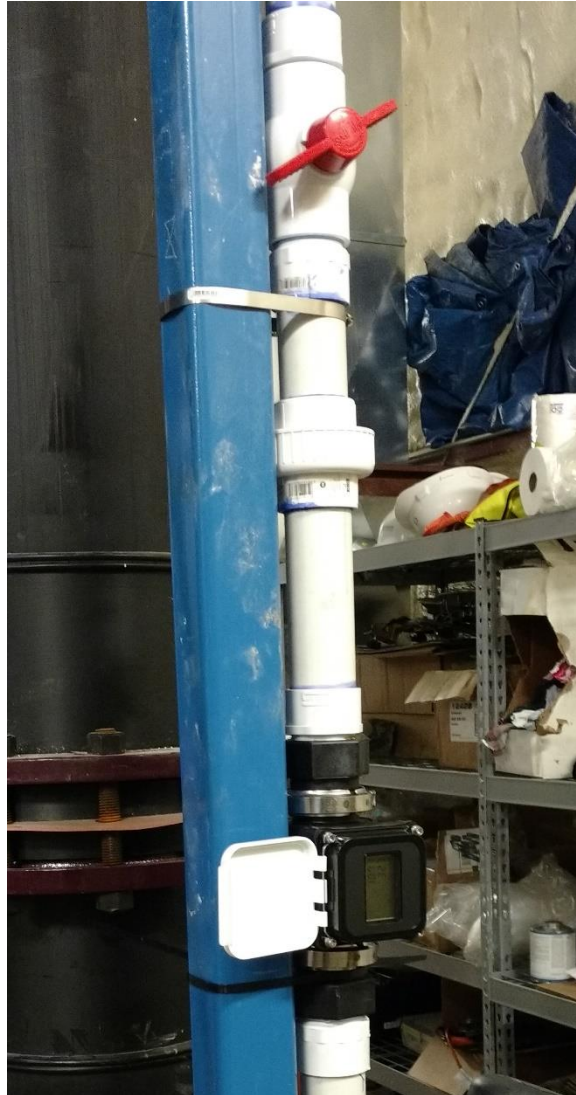
Figure 4: Inline flow-meter and throttling Valve (red handle) – Taken on 1/19/2016

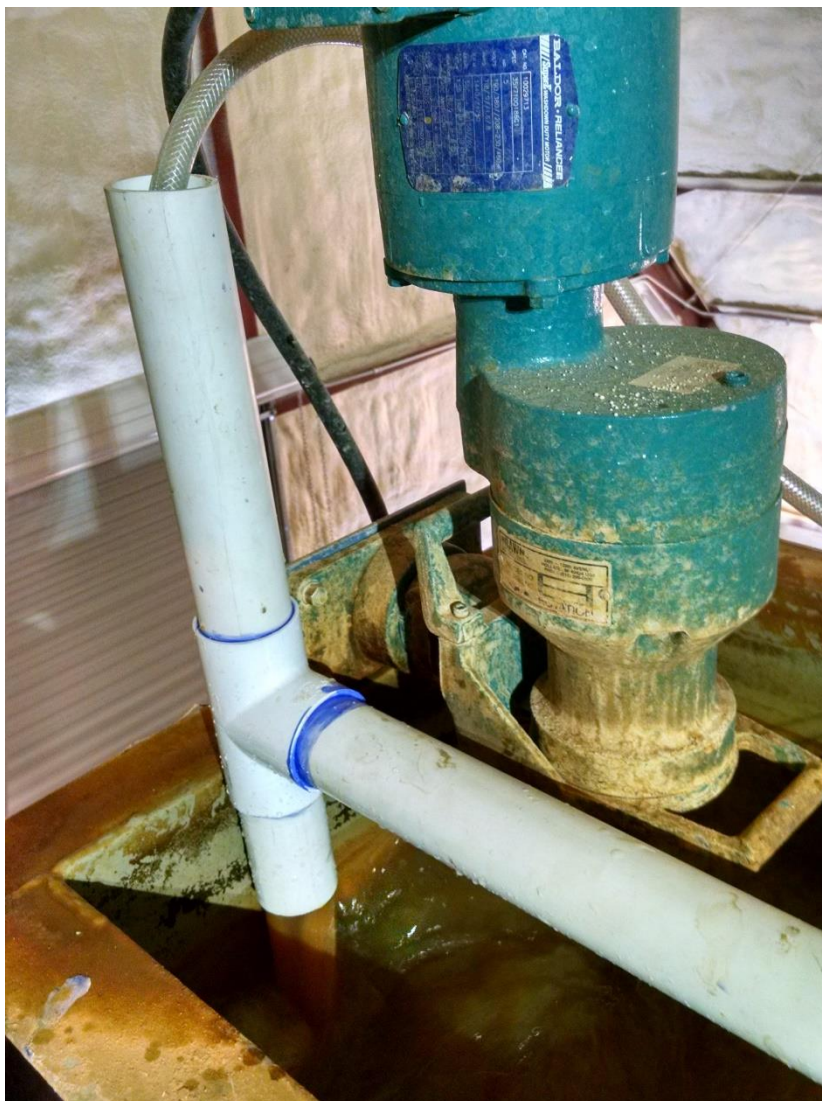
Figure 5: Injection point where sludge water from Cell D is mixed with floc and added to the flash tank to be agitated, joined with the incoming water from the reactor tank, and reprocessed – Taken on 1/19/2016

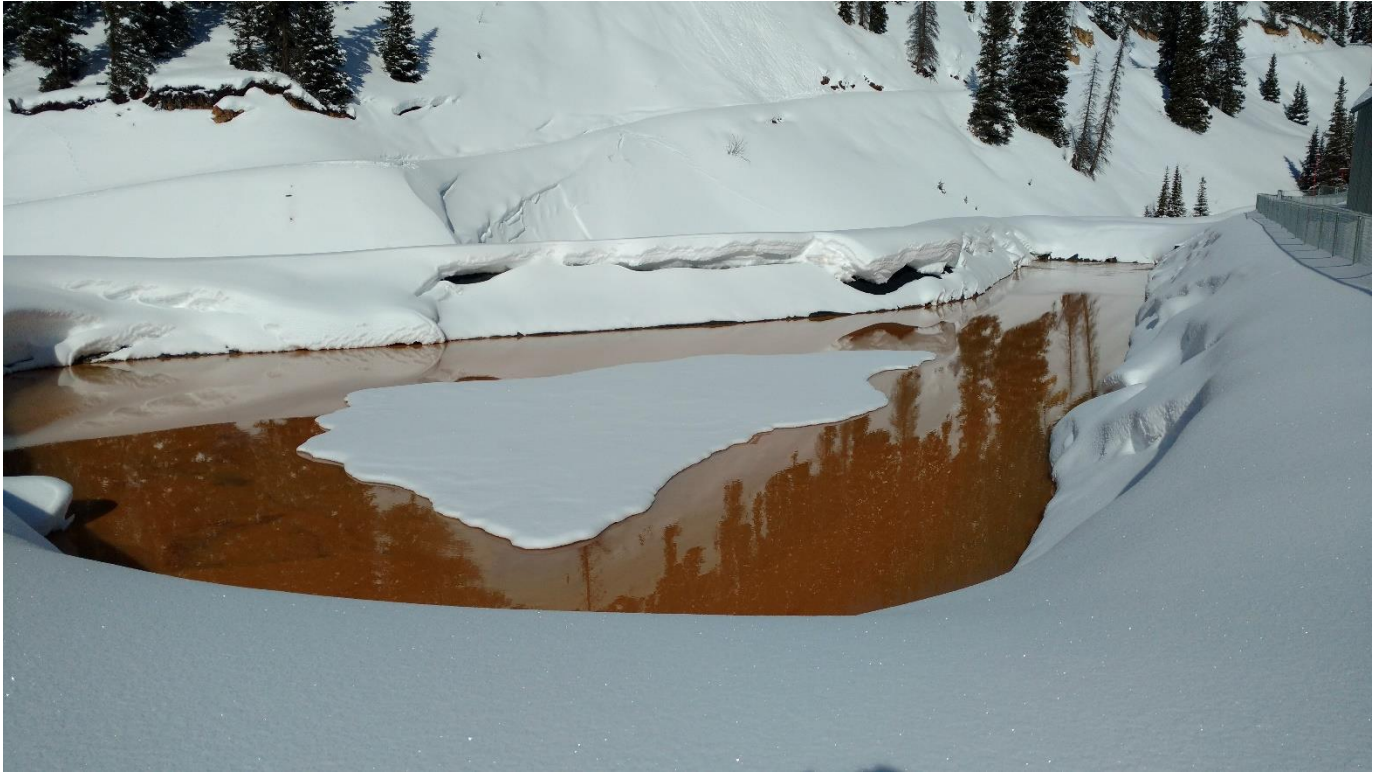
Figure 6: Picture of the equalization pond with Gold King IWTP inlet pipes shown on the far left – Taken on 1/19/2016
